AN ASSESSMENT ON THE ENVIRONMENTAL EFFECTS OF FLOOD ON COMMUNITIES IN SOKOTO EASTERN ZONE OF NIGERIA

Muhammad Yanda and Musa Dalhatu
Umaru Ali Shinkafi Polytechnic, Sokoto
mymyanda7@gmail.com

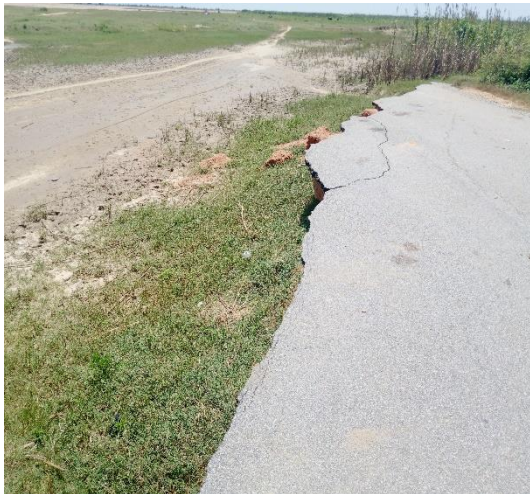
Plate 1: Washed away Road at Isa L.G.A. Plate 2: Road under threat of being washed out at Sabon Birni L.G.A.

4. The government should look at the possibility of reconstructing the Isa-Bafarawa road, raise the barrier, and provide adequate culverts along the road.

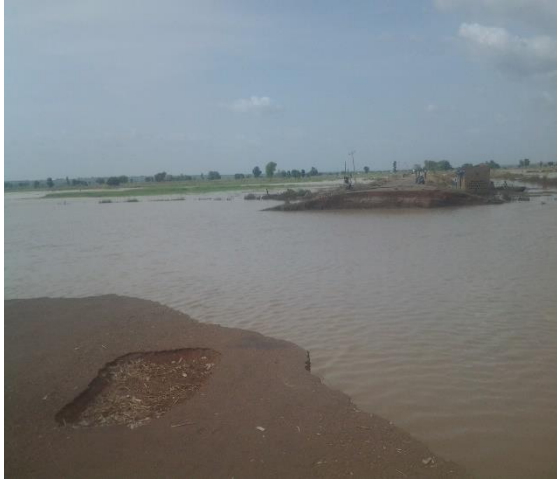
Plate 3: Washed away, Road at Wurno L.G.A. Plate 4: Submerged Farm at Illela L.G.A.

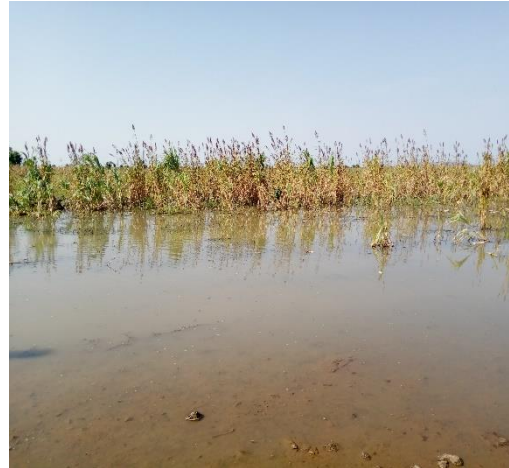
It was also observed that the Niger Republic also constructed a dam across river Maradi, which supplies the Illela canal water. This development leads to a drastic supply of water to the canal for a while. Upon the release of water from this dam during the flooding period worsened the situation at Illela L.G.A.

5. The flood in Illela L.G was due to the overflow of Kalmalo Lake due to high inflow from upstream Dams in Niger republic. The Lake was dry for many years because the influx was cut-off, but high rainfall this year forced the Dams upstream to release water, resulting in the flood of farmlands.

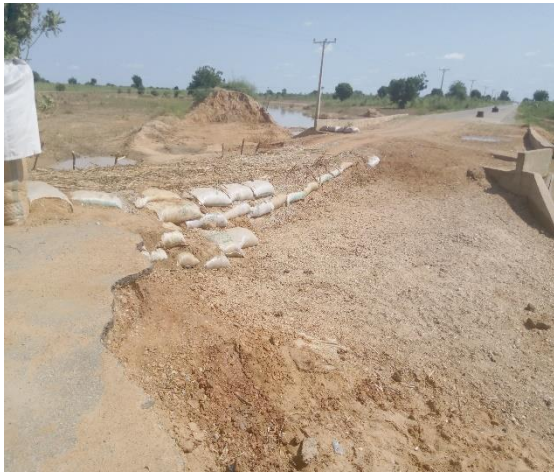
Plate 5: Washed away Road at Sabon Birni LGA Plate 6: Affected Irrigation Canal at Goronyo LGA
